# Manhole Inspection Summary

Manhole # S06II2009MH

Insp Date: **7/19/06 6:48 AM**

**Location** Address: **3321 SHELBURNE RD**

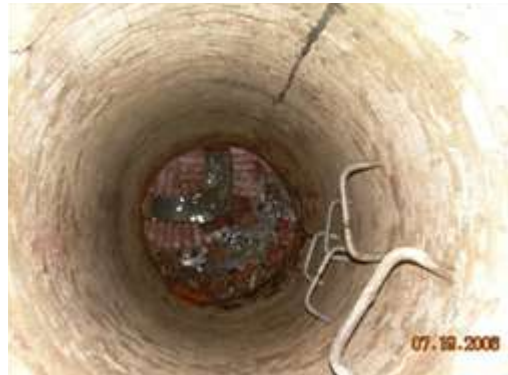
Top View

Adjustment, Corbel, and Barrel infiltration.  
Evidence of surcharge - Bench debris.  
Corroded steps. Channel debris.

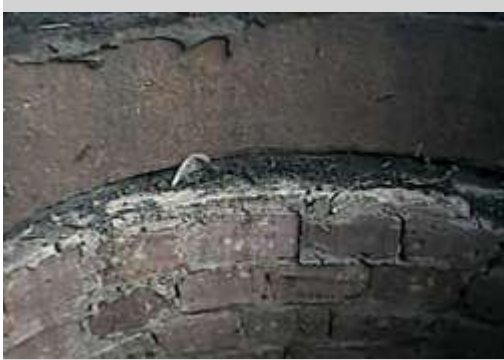
Defect

**Frame** Offset: **3** (in.) Condition: ☐ Sound ☐ Cracked ☒ **Leaks**

Condition: ☐ Sound ☐ Cracked ☐ Root Intrusion ☐ Loose Brick ☒ **Deteriorated**

Infiltration: ☐ None ☒ **Joint** ☐ Cracks ☒ **Mortar** ☐ Roots ☐ Wall

Frame leaks. Frame offset. Adjustment  
deterioration and infiltration.

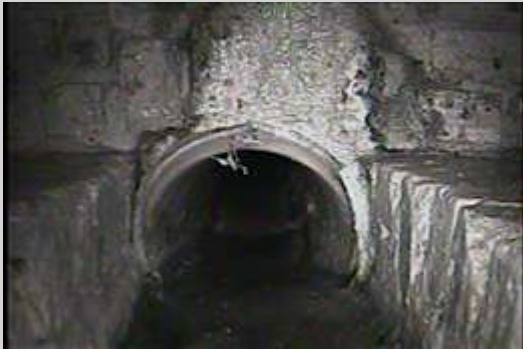
### 8 in. Circular Gravity Sewer Pipe Out @ 12 O'Clock

Barrel infiltration.

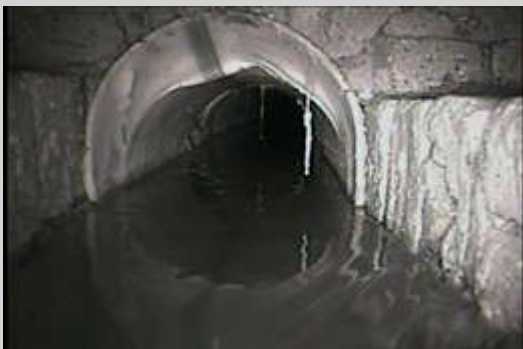
### 8 in. Circular Gravity Sewer Pipe In @ 9 O'Clock

Channel deterioration.
